Spyglass Ridge Villas

Level 2 Reserve Study

Client Reference Number	21873
Property Type	Single Family Homes
Number of Units	107
Fiscal Year End	12/31
Type of Study	Update with Site Visit
Date of Site Visit	6/30/2023
Prepared By	Ken Forney
Analysis Method	Cash Flow
Funding Goal	Full Funding

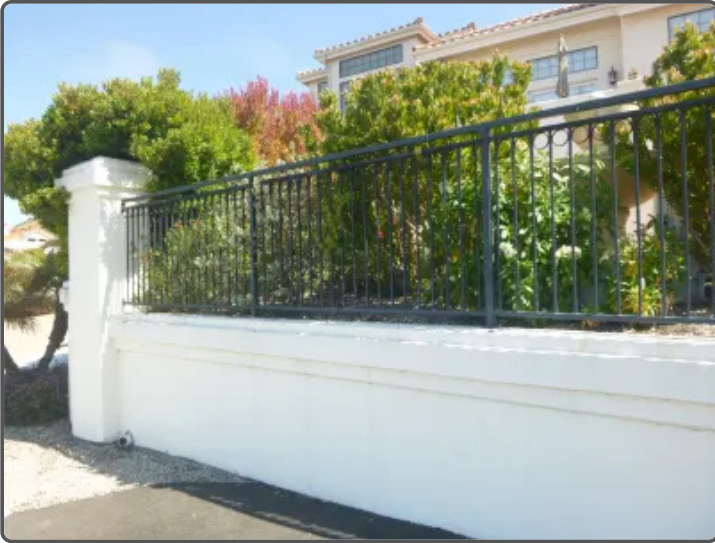
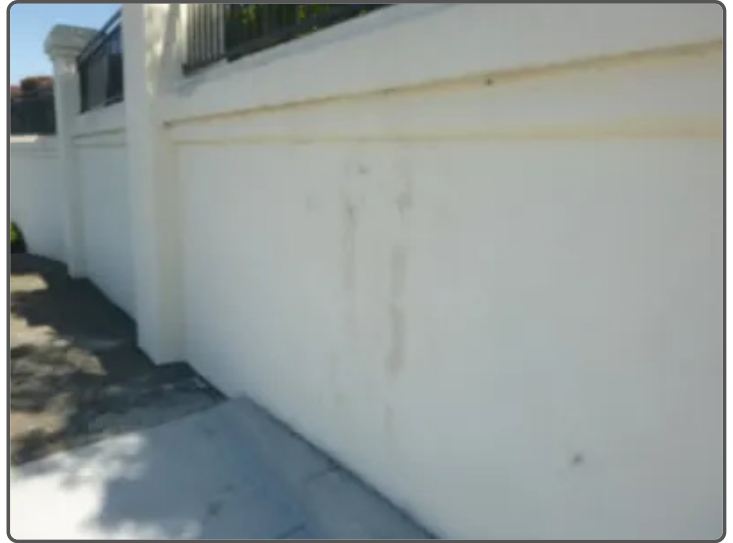
The client reported that these surfaces will be painted in the near future. Expect to repaint these surfaces approximately every 10 to 12 years to maintain appearance and protect stucco. Remaining life based on current condition.

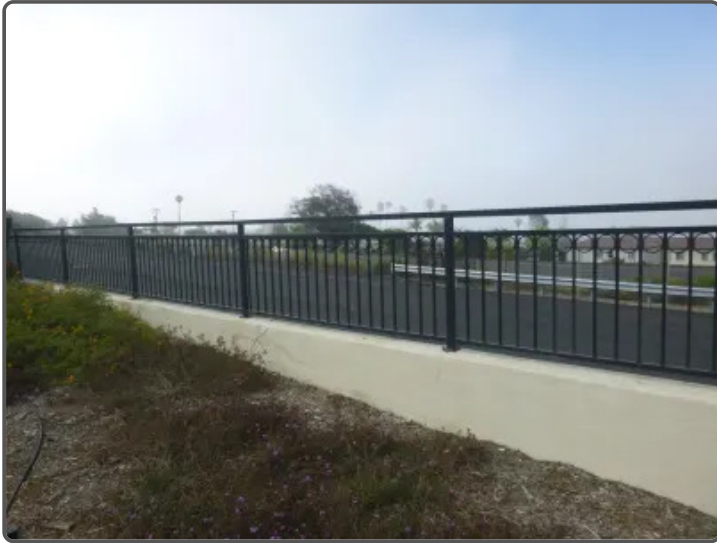
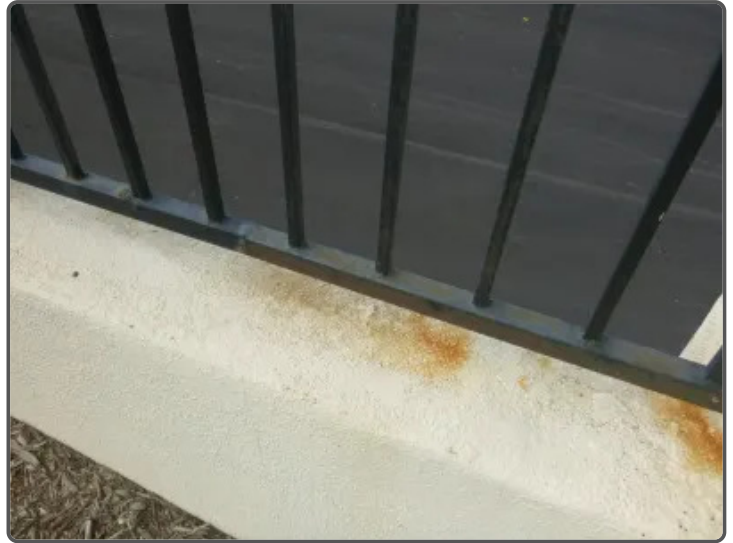
Comp # 207 Wrought Iron Fencing - Repaint

Noted fading and local rusting to the wrought iron surfaces. Expect to repaint these surfaces approximately every 3 to 5 years to maintain appearance and protect the metal material. Remaining life provided by the client.

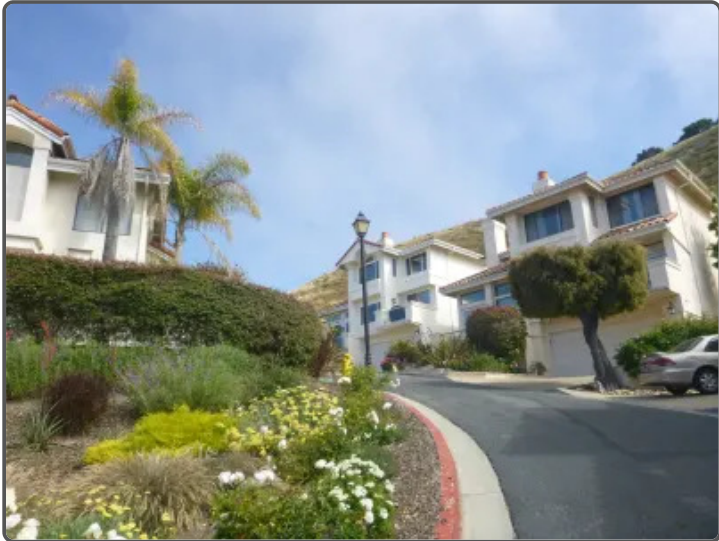
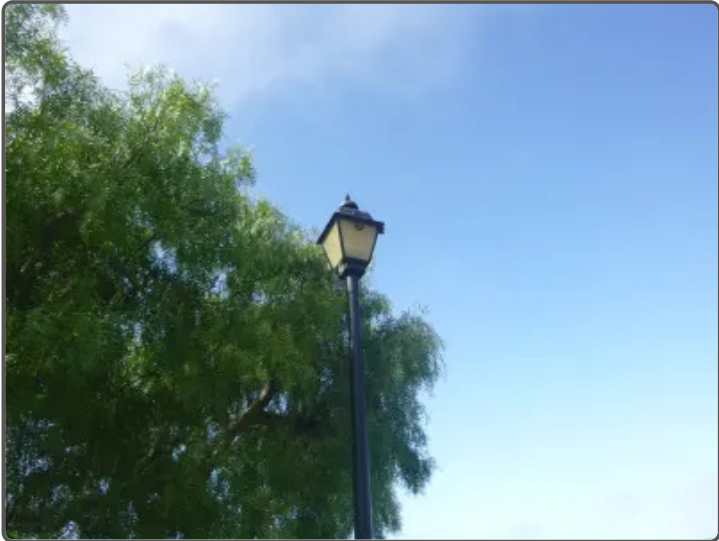
Comp # 211 Pole Light Fixtures - Repaint

We recommend funding to repaint the pole light fixtures approximately every 5 years. Remaining life provided by the client.

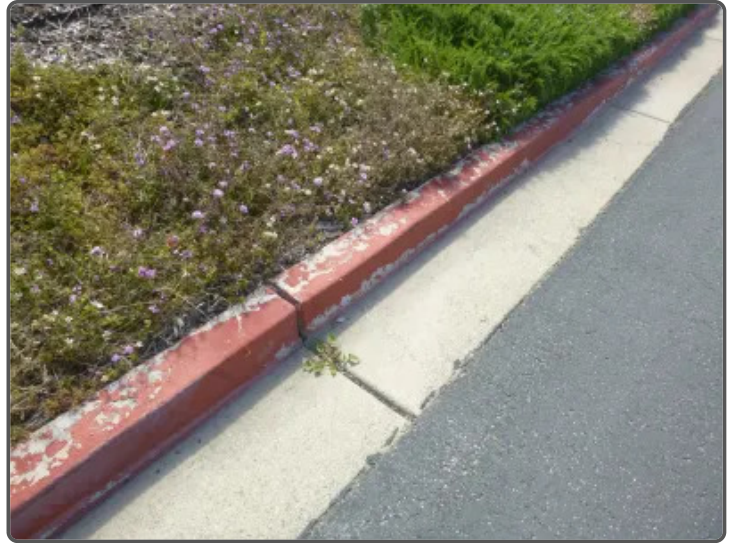
Comp # 214 Red Curbs - Restripe

Noted chipping and paint loss to the curb surfaces. We recommend repainting these surfaces at the same time as the asphalt preventative maintenance project in approximately 5 years. Project cost provided by the client.

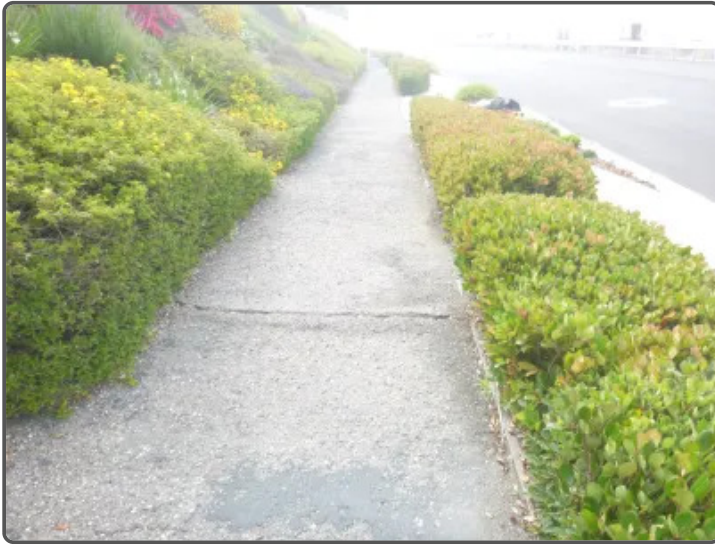
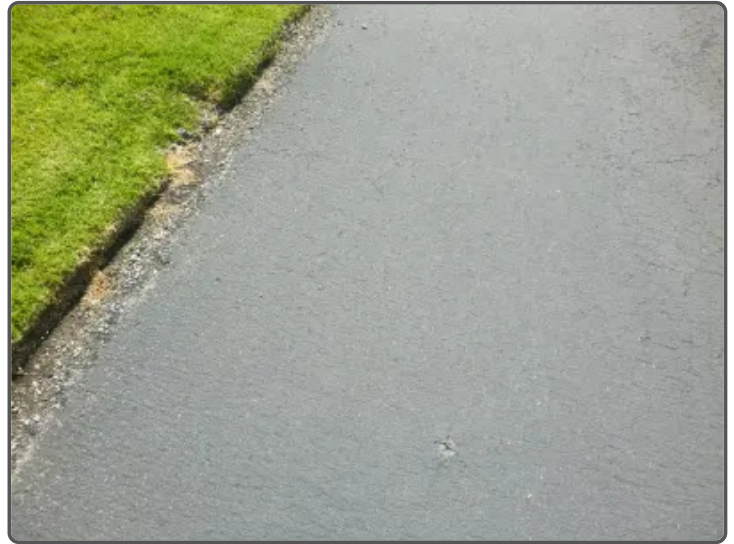
Comp # 401 Asphalt - Major Rehab. (Bike Path)(Unfunded)

The majority of the bike path is in fair to poor condition. We recommend funding to perform a major rehab to this path in the next few years based on current condition. However the client reported the association has no intention of significantly repairing or replacing this path.

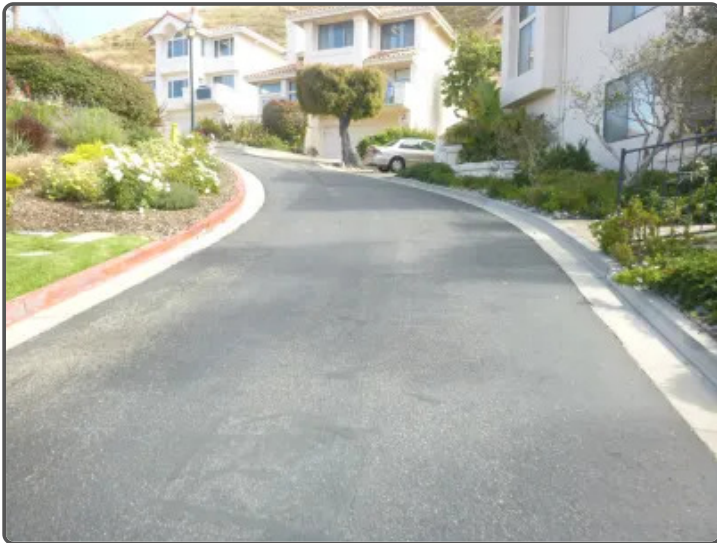
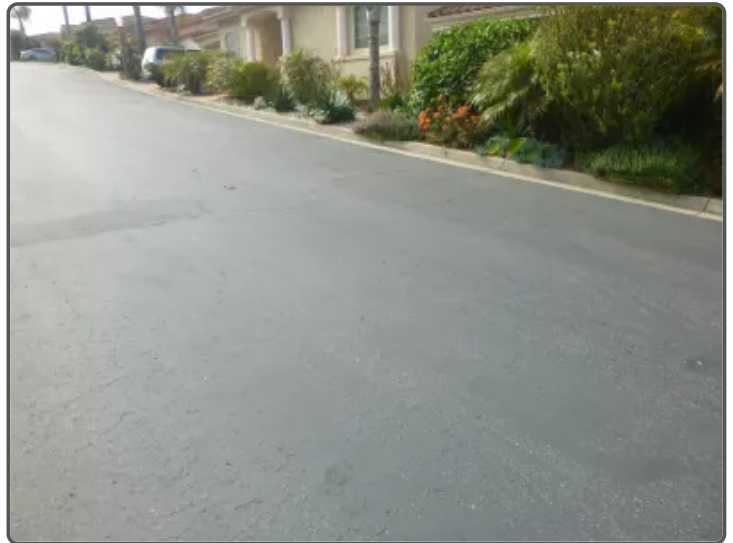
Comp # 401 Asphalt - Major Rehab. (Community Streets)(Overlay)

The asphalt surfaces are older and generally nearing their intended useful lives. It was reported that the association intends to perform a major rehab in the next few years.

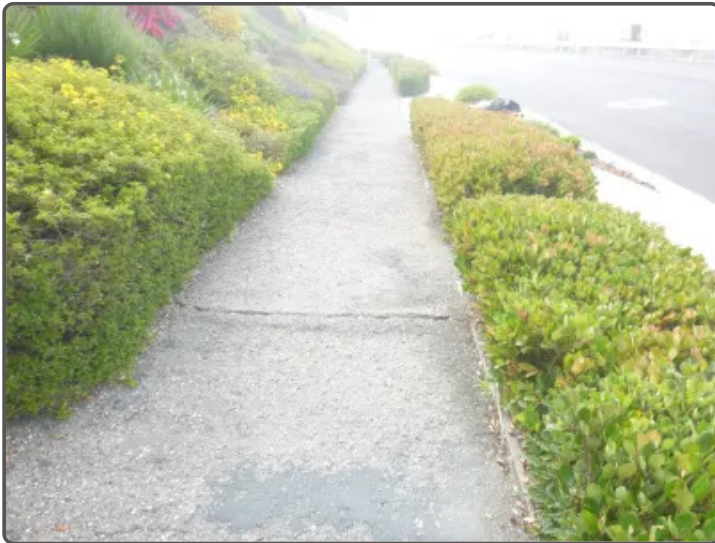
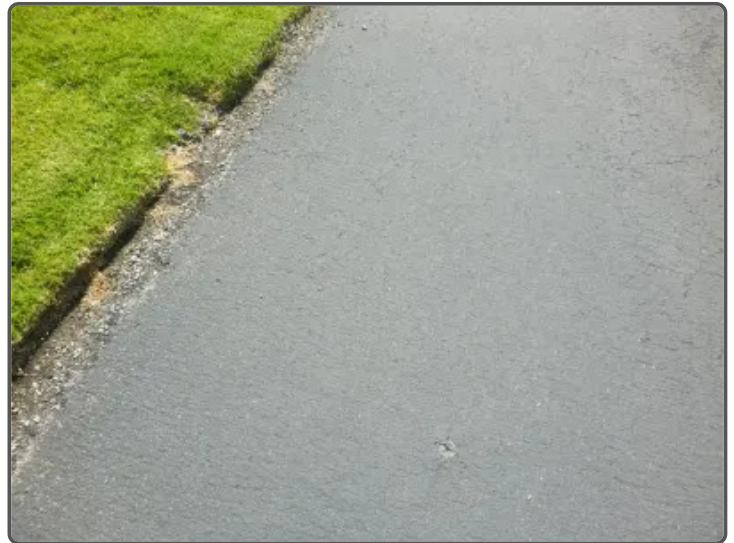
Comp # 402 Asphalt - Preventive Maintenance (Bike Path)

Noted seal loss throughout. Asphalt is generally in fair to poor condition and should be sealed in the near future. However the client reported that association will be sealing these surfaces at the same time as the asphalt major rehab project.

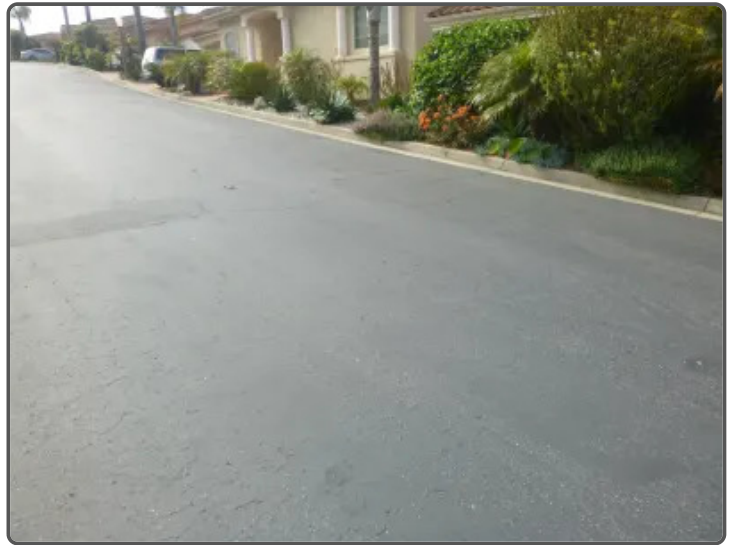
Comp # 402 Asphalt - Preventive Maintenance (Community Streets)

Noted local areas of seal loss to the asphalt surfaces. These surfaces should generally be resealed every 3 to 5 years to protect the asphalt material and prevent a premature major rehab. These surfaces should be resealed in the near future based on current condition. However we have deferred this project until the asphalt major rehab project in approximately 3 years.

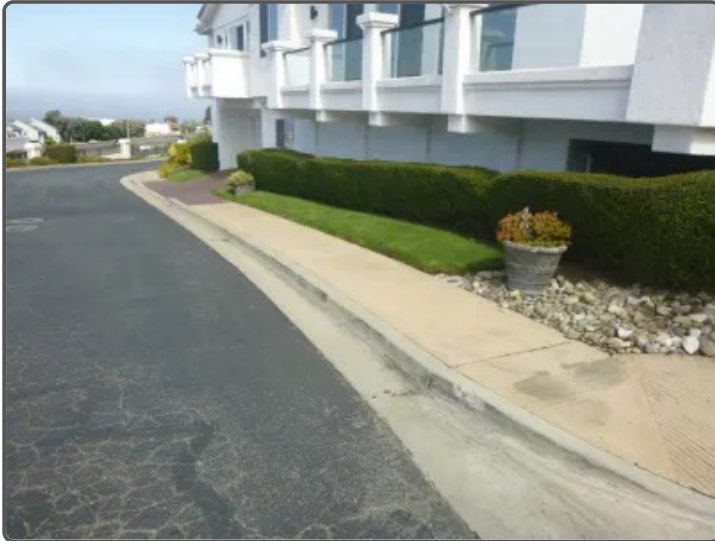
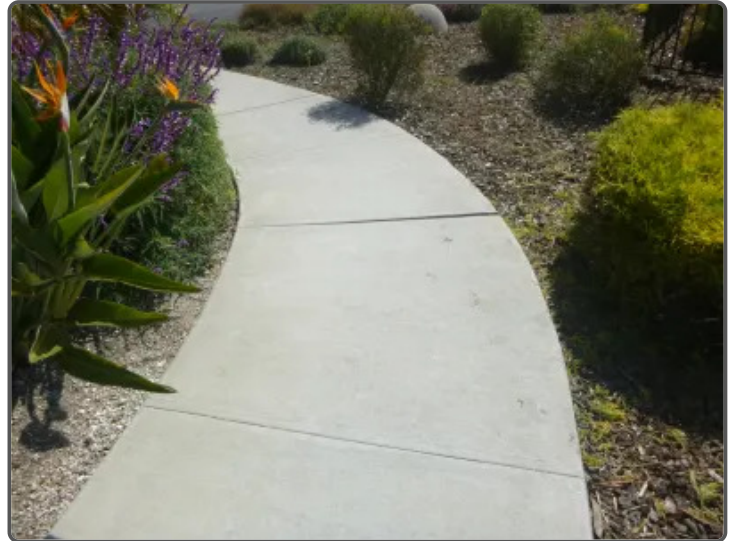
Comp # 403 Concrete - Repair/Replace

No expectation to completely replace the concrete surfaces. We recommend funding for an allowance for periodic repairs. Remaining life and replacement cost provided by the client.

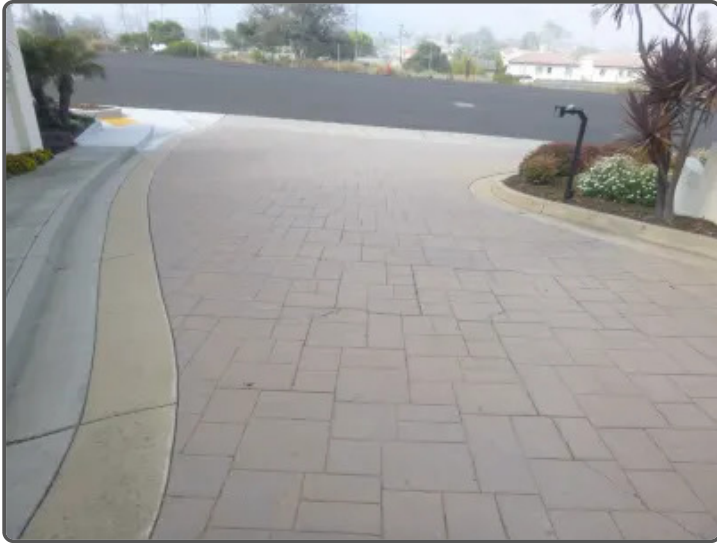
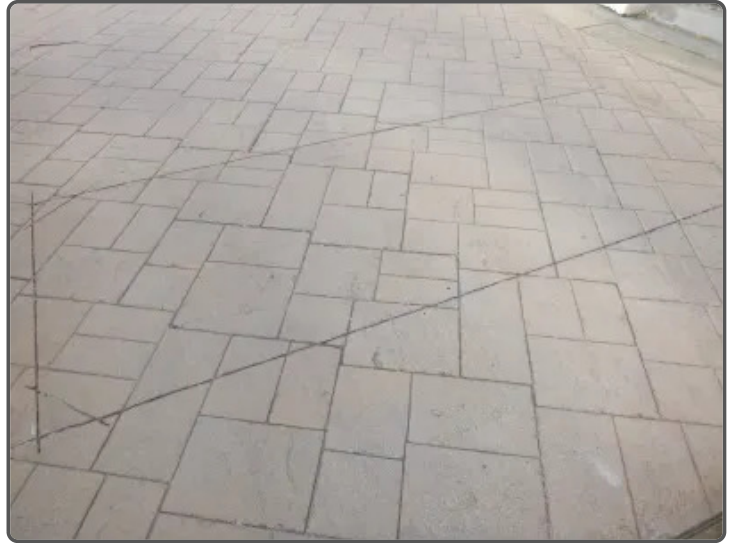
Comp # 405 Stamped Concrete - Repair/Replace

No significant cracking or structural problems noted with the stamped concrete. We recommend making local repairs as necessary as an operating expense and funding to replace this concrete approximately every 25 to 30 years

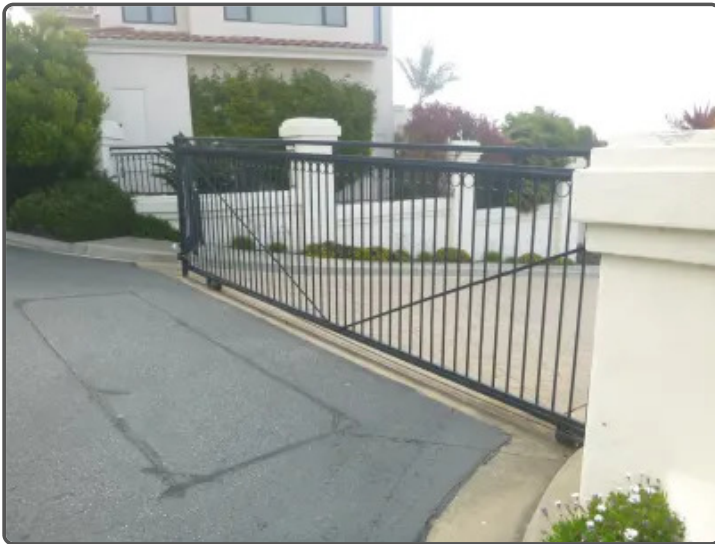
Comp # 504 Vehicle Gates - Replace

Although these gates may reach an extended life we recommend funding for their replacement approximately every 30 years to ensure appearance and function. We have included funding for the replacement of the adjacent pedestrian gates and fencing at the same time.

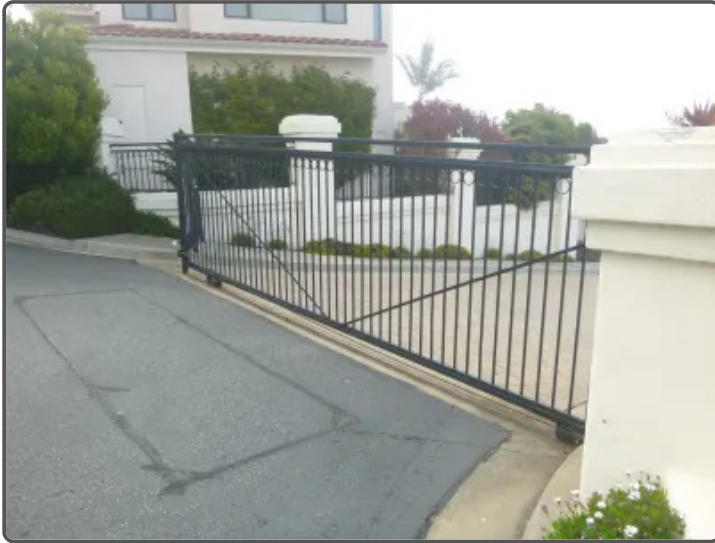
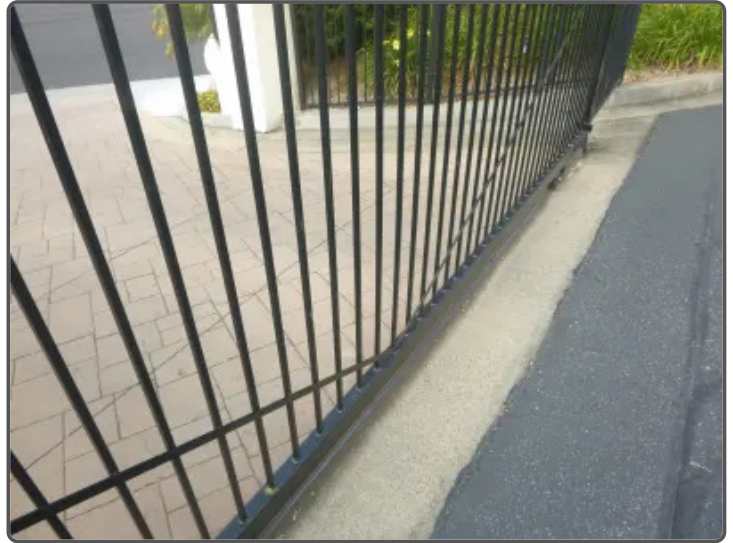
Comp # 504 Vehicle Gates - Replace (Consuetta Exit)

It was reported that the Consuetta Exit gate was recently replaced. Although this gate may reach an extended useful life we recommend funding for its replacement approximately every 25 to 30 years.

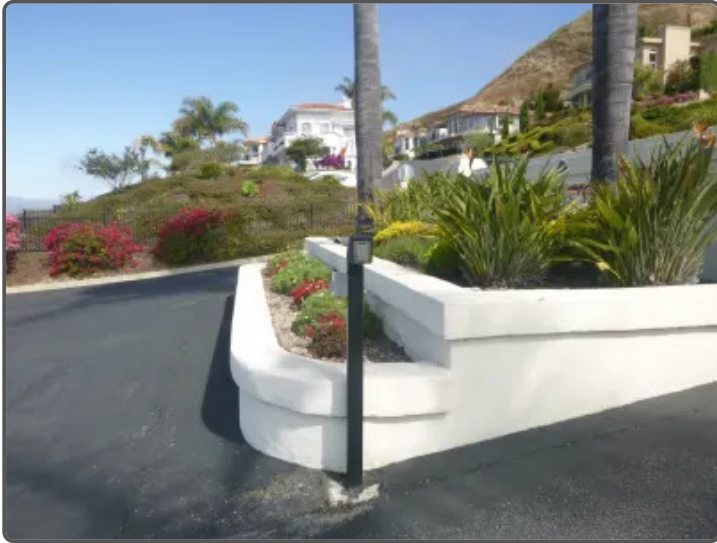
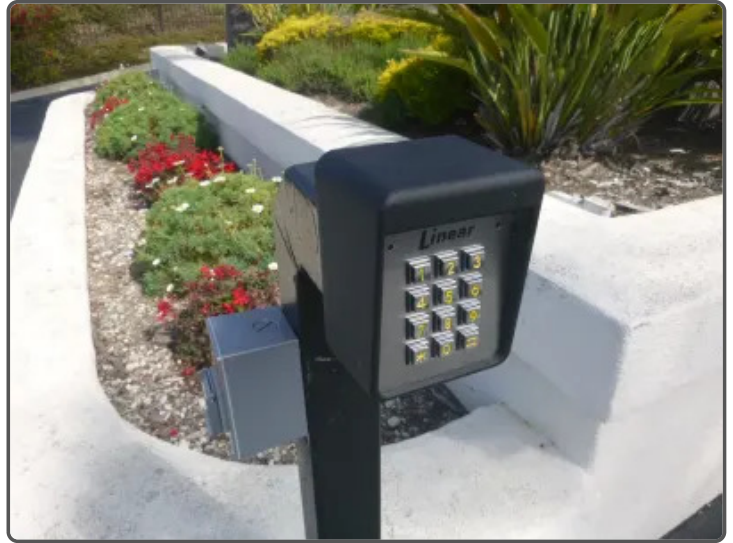
Comp # 506 Access System - Replace

The client reported that the phone entry systems were recently replaced with a keypad system. We recommend funding to rebuild or replace these pads approximately every 15 years.

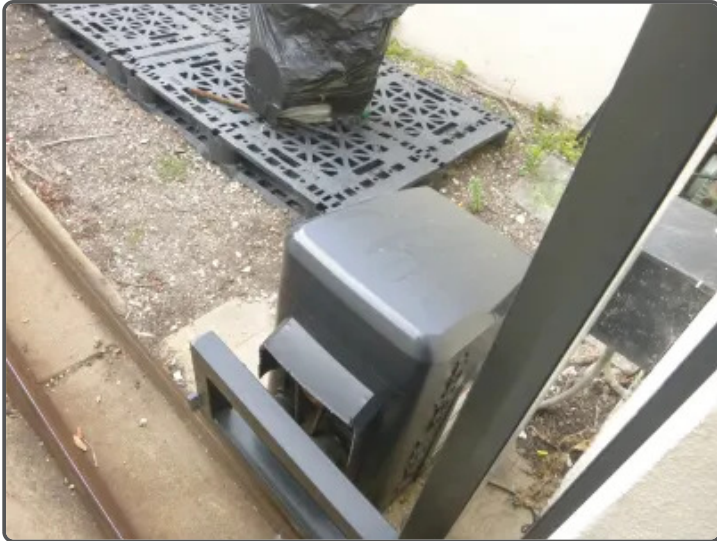
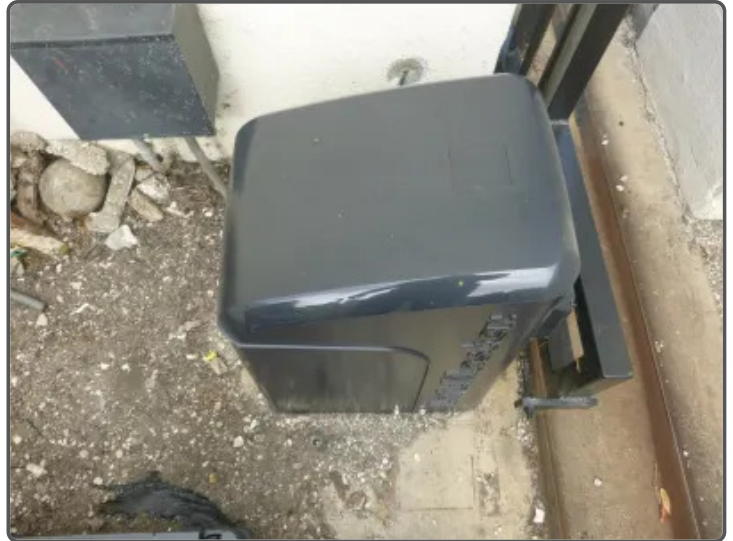
Comp # 507 Vehicle Gate Operators - Replace (Consuetta Entry)

LiftMaster
Mod# CSW24UL
Ser# 3222N1211
08/03/22

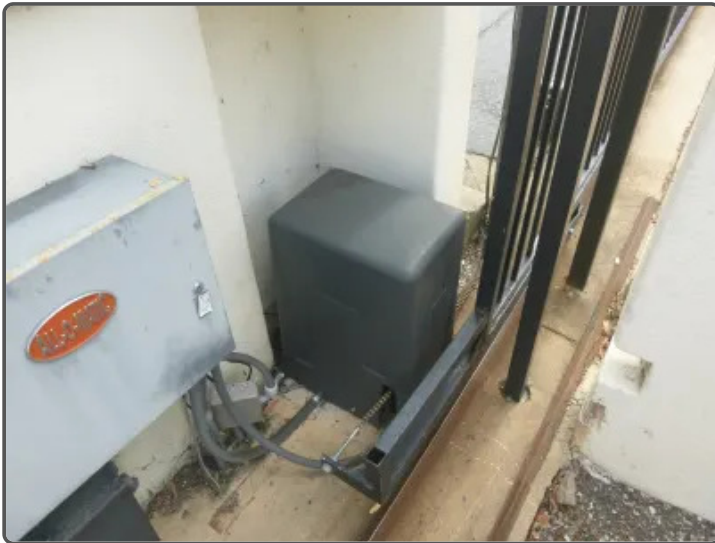
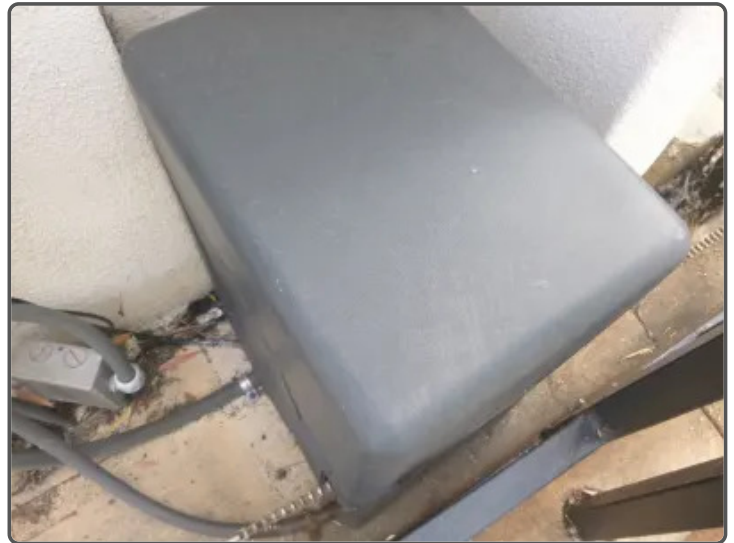
Comp # 507 Vehicle Gate Operators - Replace (Consuetta Exit)

This operator is older although observed to be functioning normally. We recommend funding to replace this operator in the next few years based on current age.

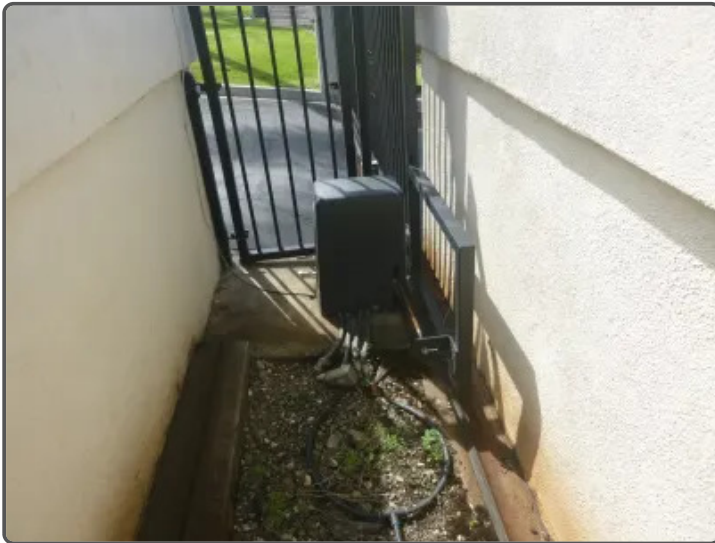
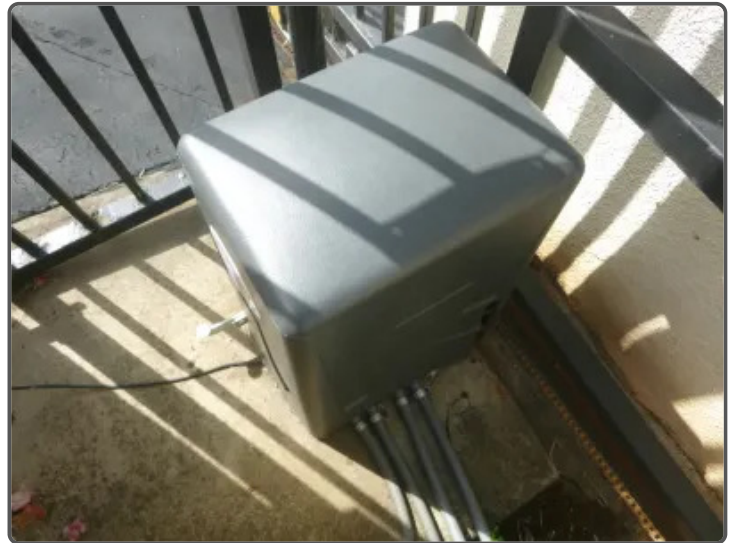
Comp # 507 Vehicle Gate Operators - Replace (Valencia Entry)

It was reported that this operator was replaced after our site visit. Expect a useful life of approximately 10 years from this operator.

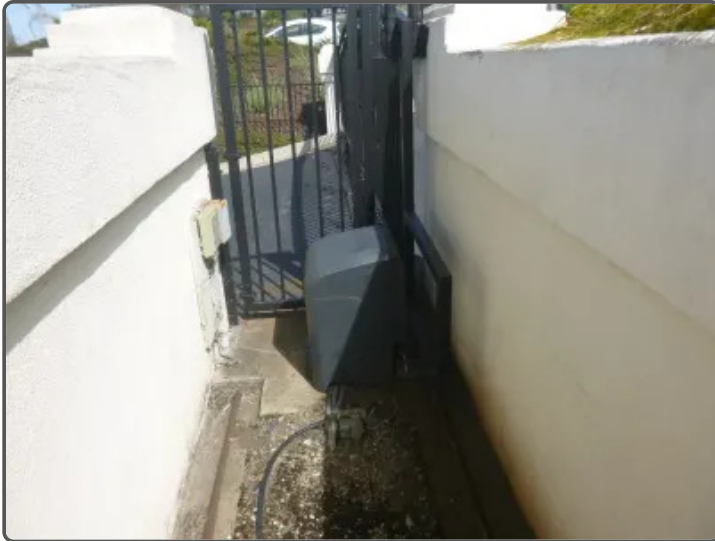
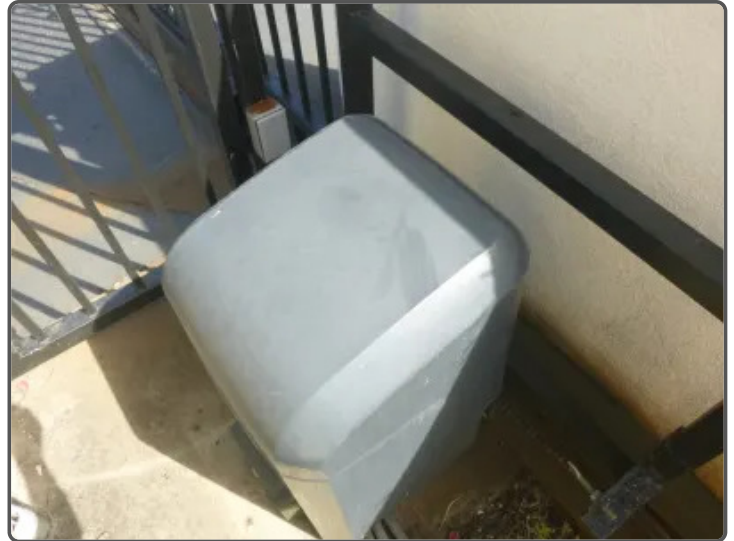
Comp # 507 Vehicle Gate Operators - Replace (Valencia Exit)

LiftMaster
Mod# SL300501UL
Ser# 2818N1543
07/09/18

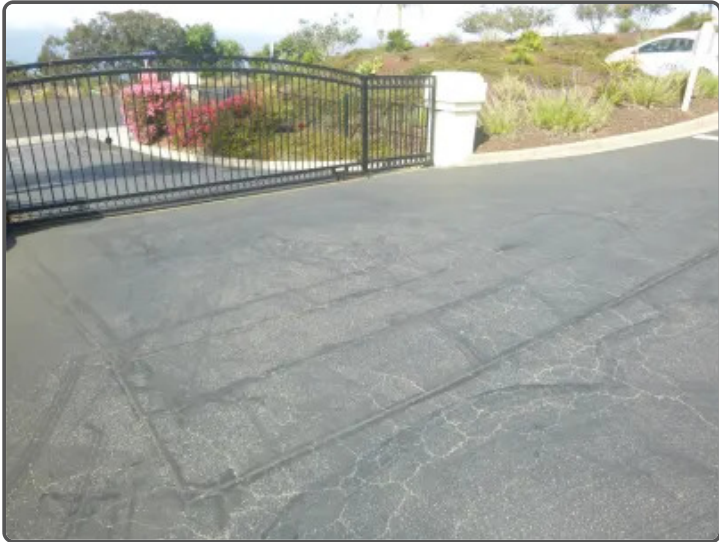
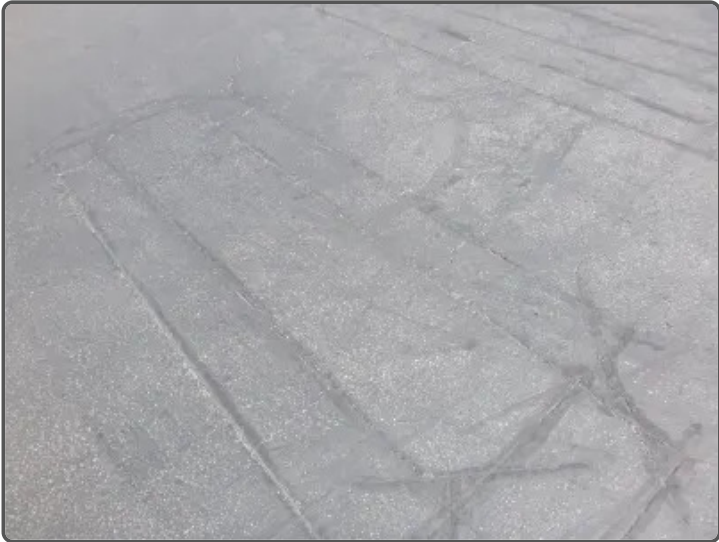
Comp # 508 Gate Loops - Replace

No reports of problems with the gate loops. We recommend replacing these loops at the same time as the asphalt major rehab project. No separate reserve funding necessary.

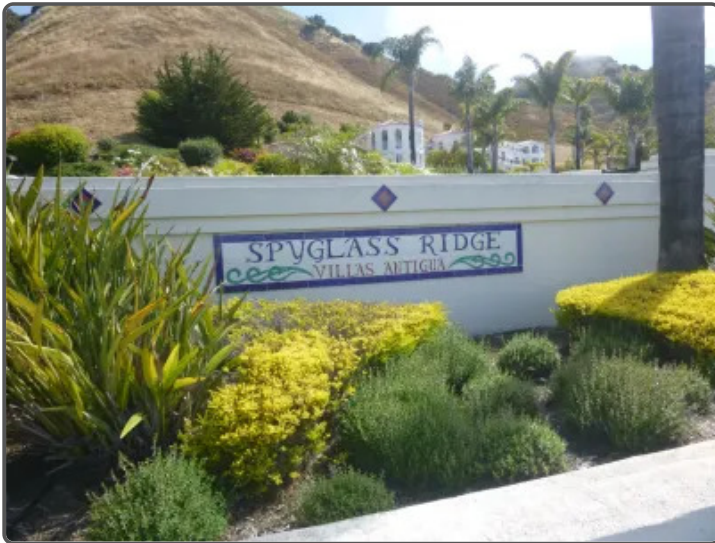
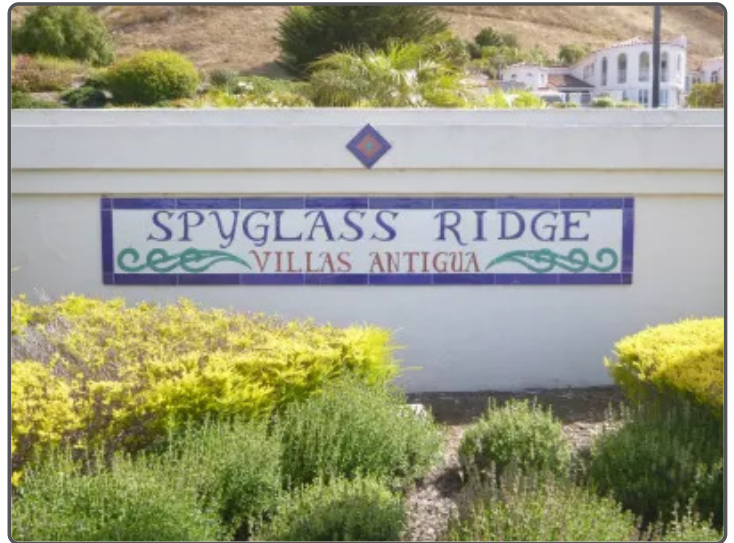
Comp # 801 Monument - Refurbish

Although these monuments may experience an extended useful life we recommend funding to refurbish this component approximately every 20 years to maintain appearance and keep up with current decorative tastes.

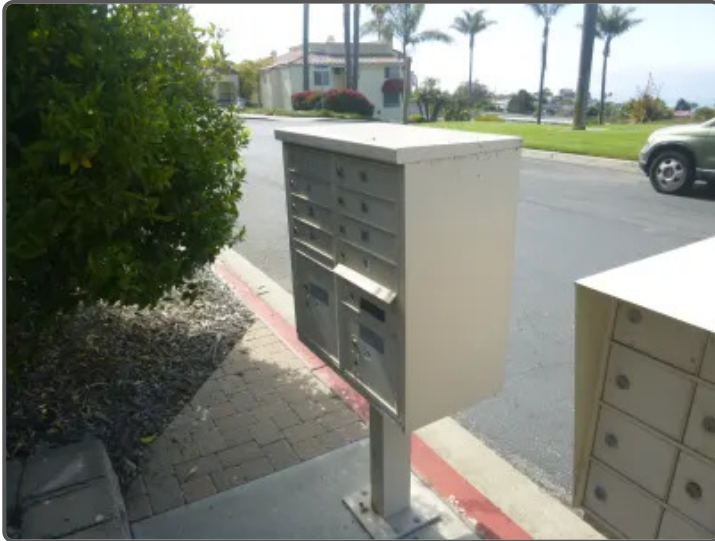
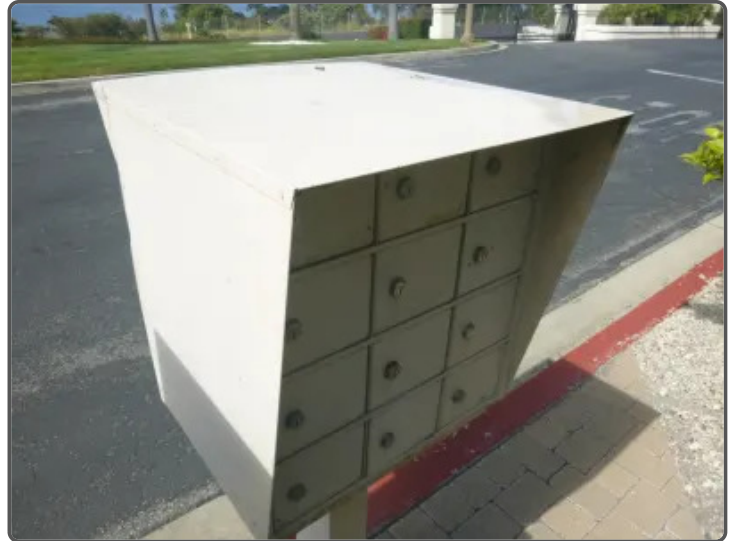
Comp # 803 Mailboxes - Replace

- (6) 16-box clusters
- (6) 12-box cluster
- (1) 8-box cluster

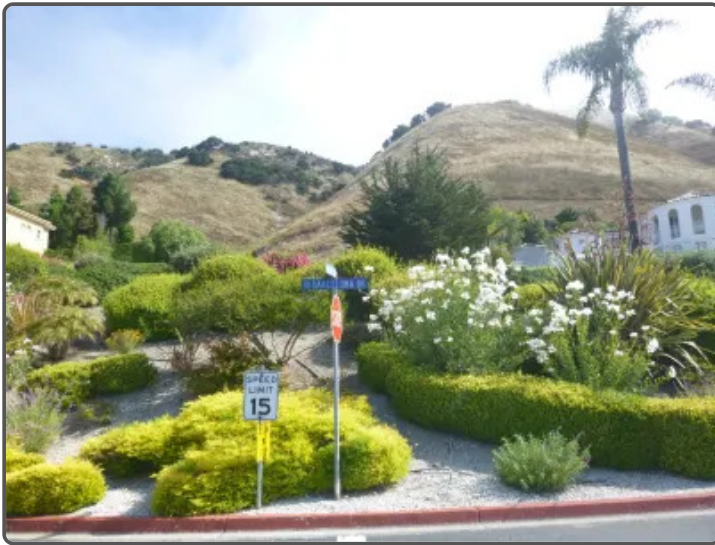
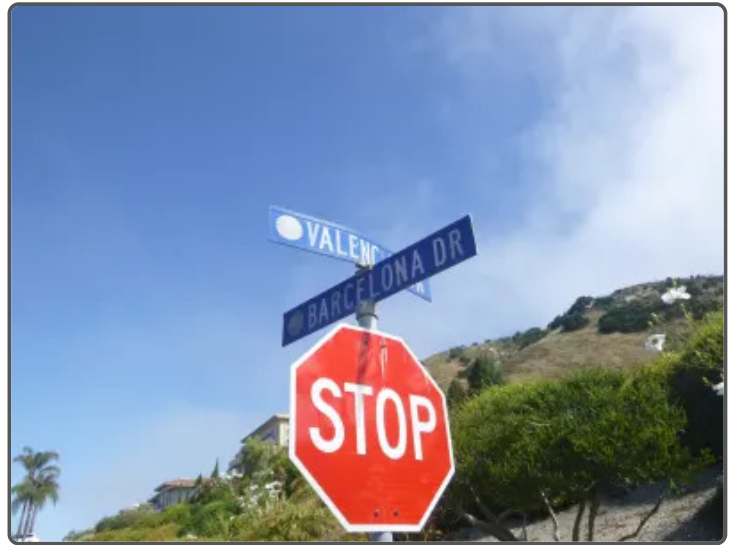
Comp # 808 Street Signs - Replace

Signs are in good to fair condition. Although these signs may reach an extended life we recommend funding to replace them approximately every 20 years. Note: No expectation to replace all of the traffic control signs (no parking, stop signs, etc.) at one time. Due to the minimal individual cost of those signs we recommend replacing them as necessary as an operating expense.

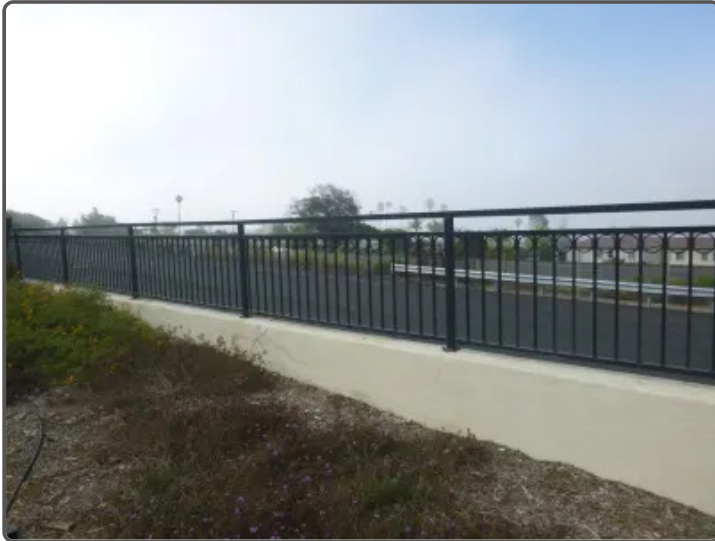
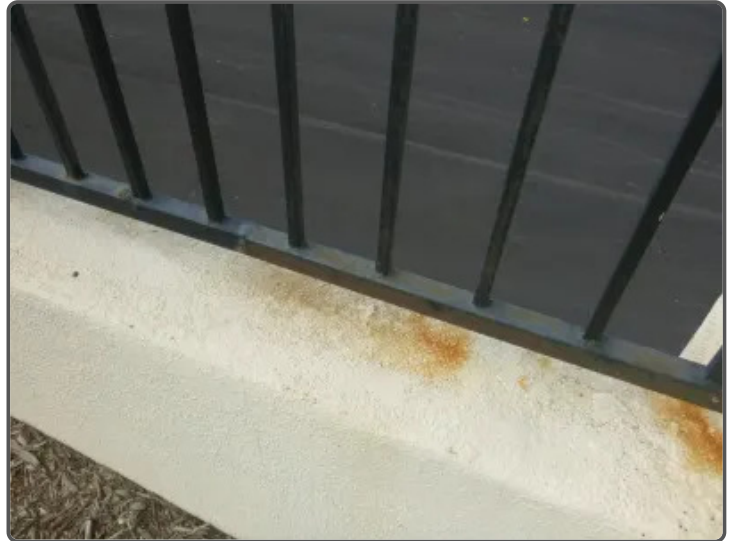
Comp # 1002 Wrought Iron Fencing - Replace

Noted local rusting although not structural issues noted with the wrought iron fencing. We recommend funding to make partial replacements to this fencing approximately every 15 years.

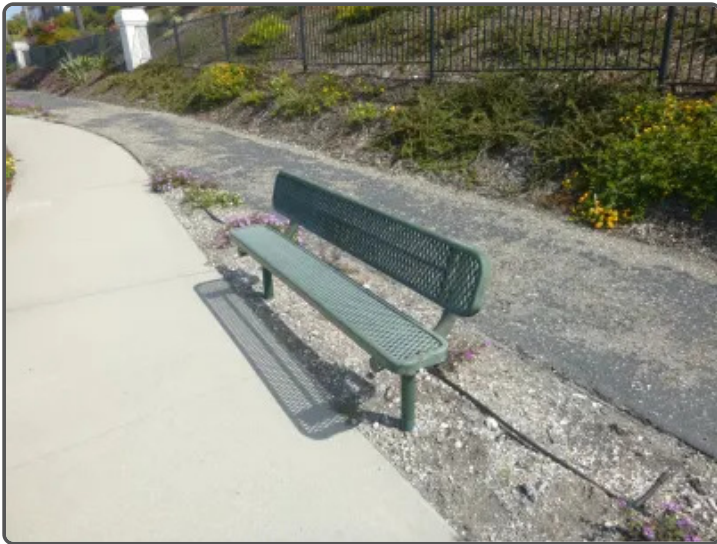
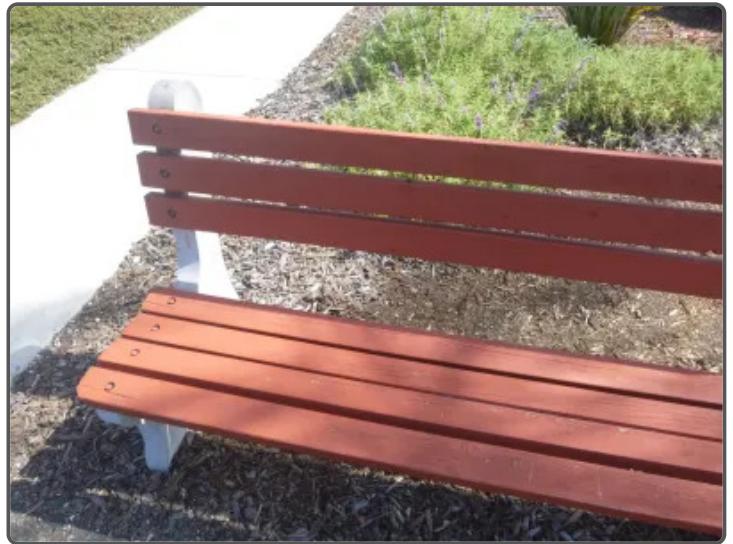
The age and condition of the benches generally varies. It was reported that these benches were donated and will not be replaced.

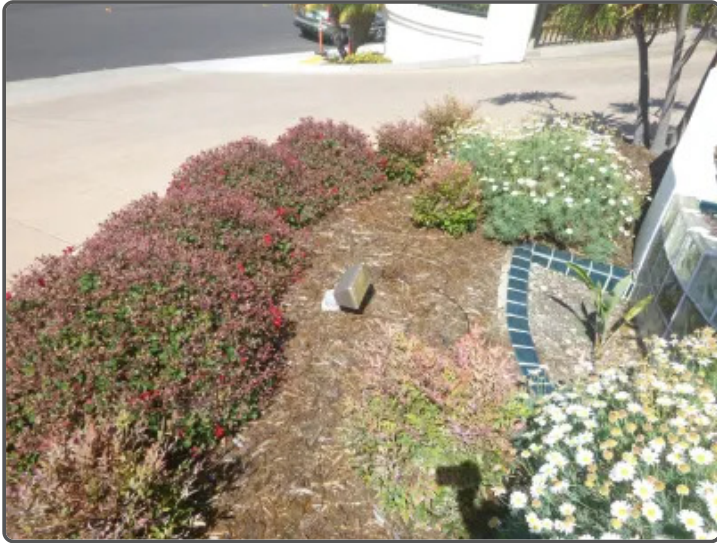
Comp # 1603 Entry & Monument Lights - Replace

No problems noted or reported. Although these lights may reach an extended life we recommend funding to replace them approximately every 15 to 20 years. Remaining life based on current condition.

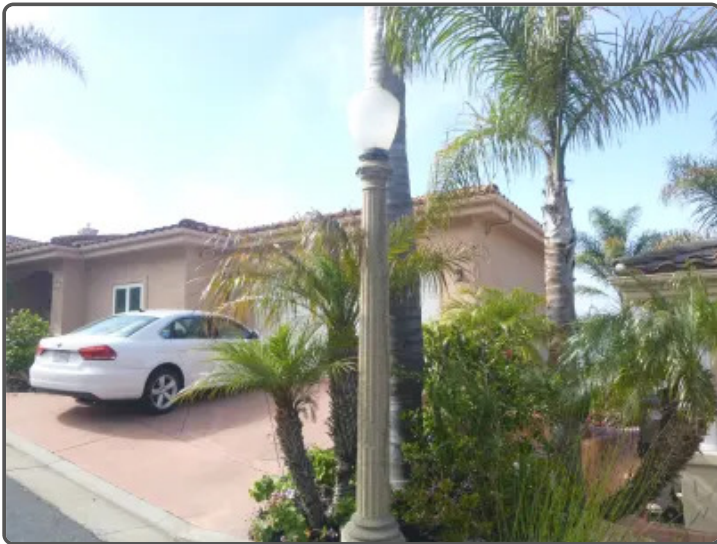
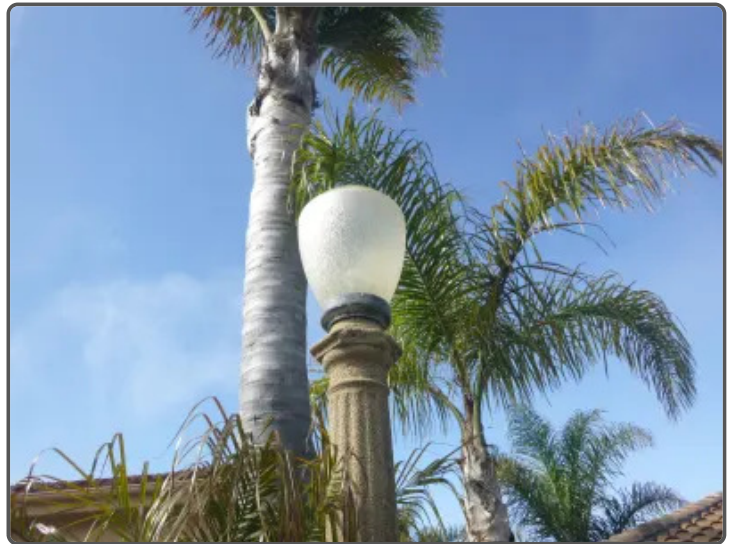
Comp # 1604 Pole Light Fixtures - Replace (Concrete)

Noted local cracking to the concrete pole supports. We have funded for a allowance to make replacements to the pole light fixtures, make local pole replacements and refurbish the electrical approximately every 25 years. Remaining life provided by the client.

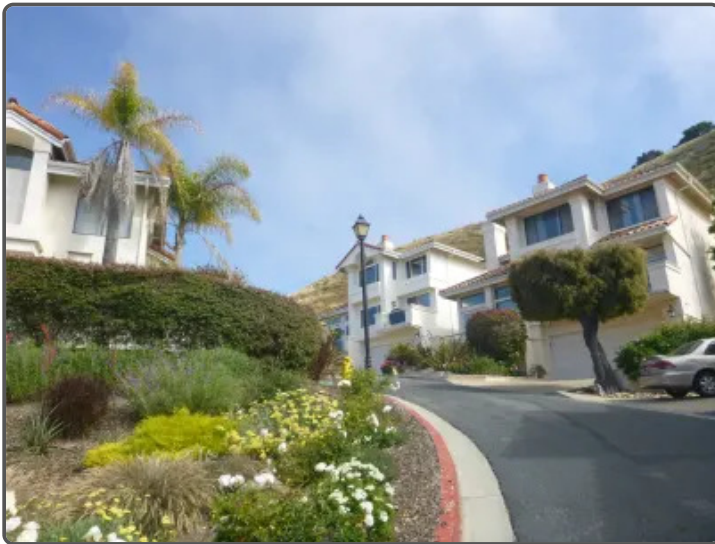
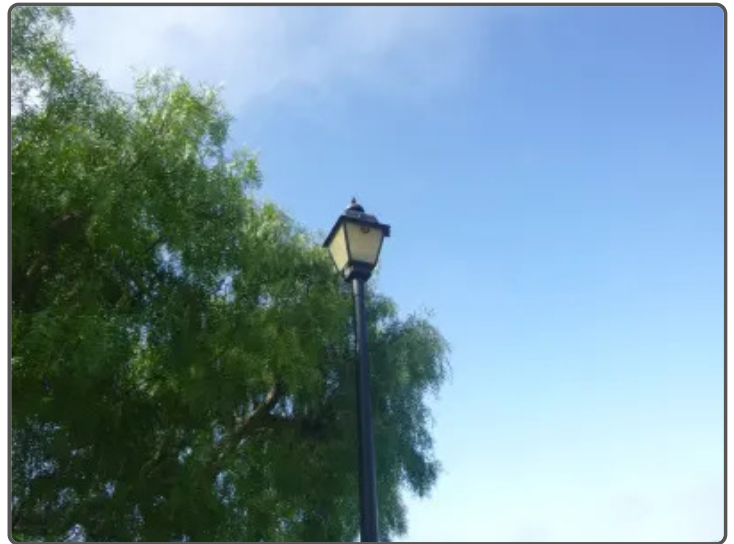
Comp # 1604 Pole Light Fixtures - Replace (Metal)

No problems noted or reported. No expectation to completely replace the poles under normal circumstances. We recommend funding to replace the fixtures, make local pole replacements and to generally refurbish the electrical approximately every 25 years. Remaining life provided by the client.

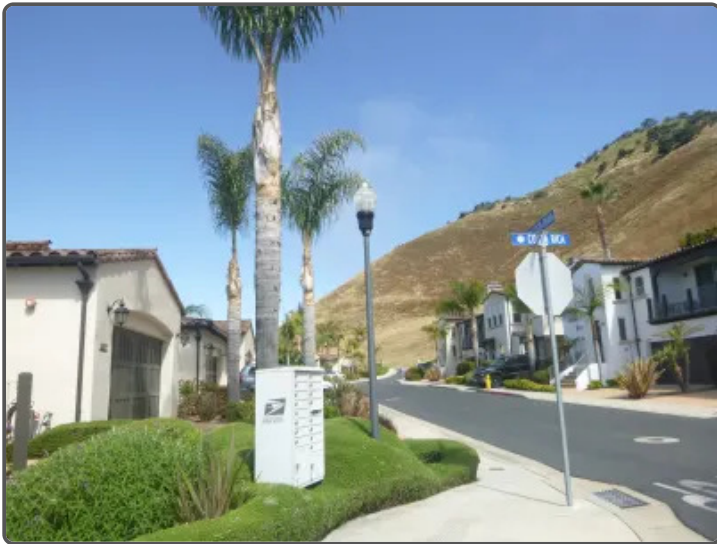
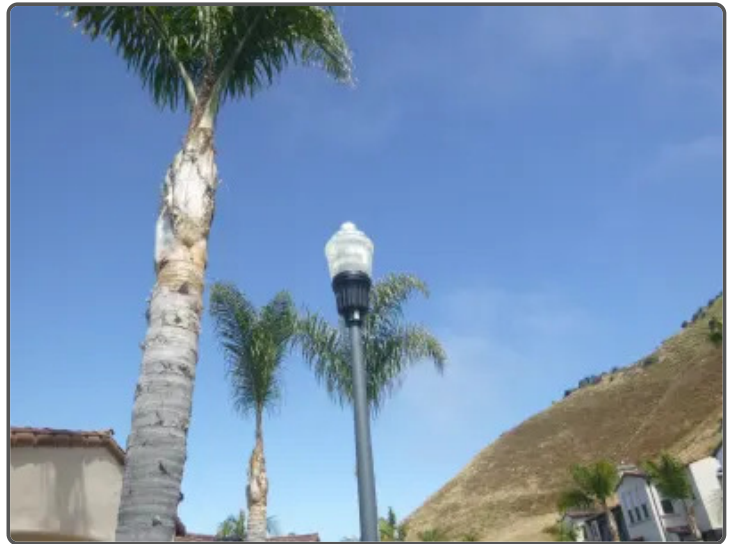
Comp # 1609 Street Light Fixtures - Replace (Operating Expense)

No expectation to replace the street light poles. We recommend funding to replace the street light fixtures approximately every 25 years. However the client reported that these fixtures are replaced when necessary as an operating expense.

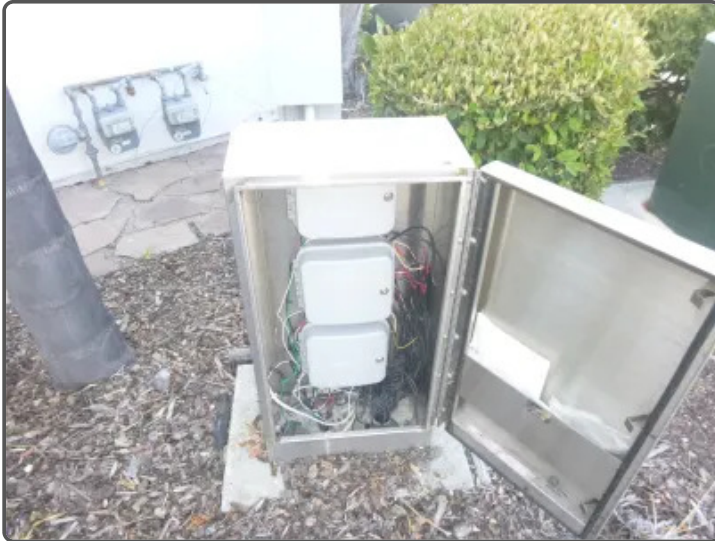
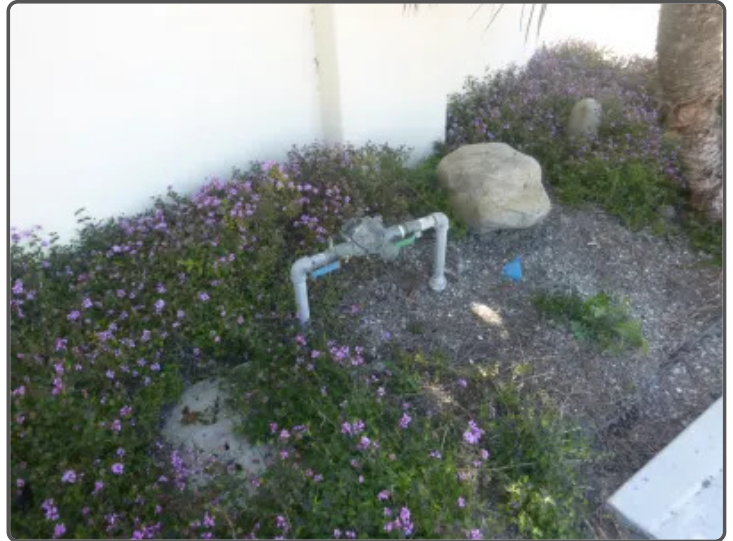
Comp # 1703 Irrigation Time Clocks - Replace

No problems noted with irrigation clocks at the time of inspection. This type of clock has a typical useful life of approximately 10 to 12 years. Remaining life provided by the client.
