Spyglass Ridge Villas

Level 2 Reserve Study

Client Reference Number	21873
Property Type	Single Family Homes
Number of Units	107
Fiscal Year End	12/31
Type of Study	Update with Site Visit
Date of Site Visit	6/30/2023
Prepared By	Ken Forney
Analysis Method	Cash Flow
Funding Goal	Full Funding

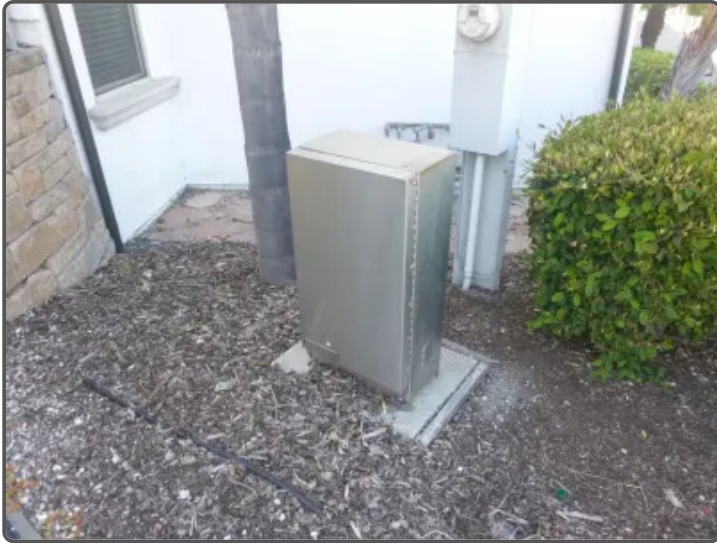
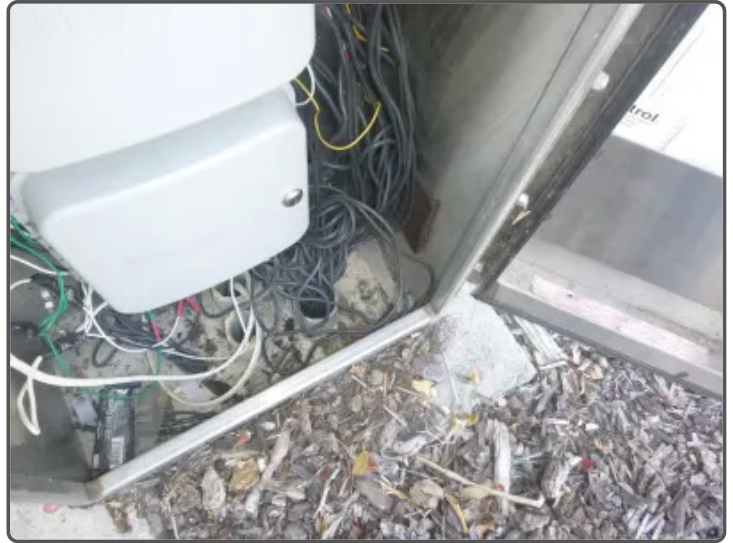
Comp # 1704 Time Clock Enclosures - Replace

Although this enclosure may experience an extended useful life we recommend funding for its replacement approximately every 25 to 30 years.

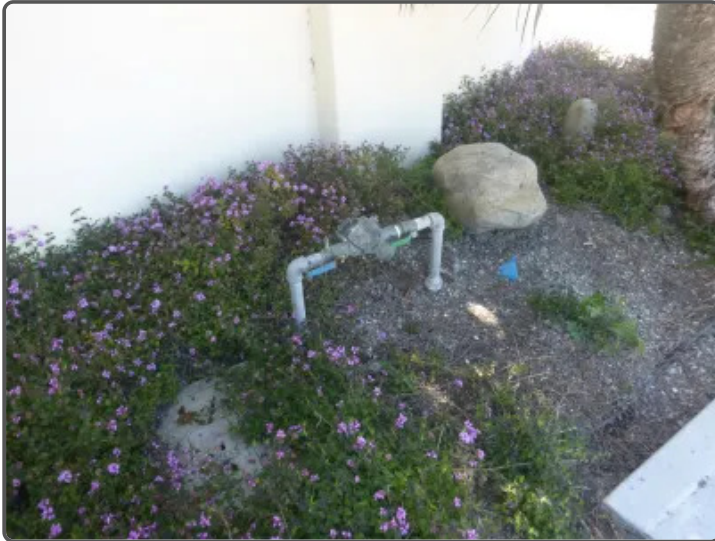
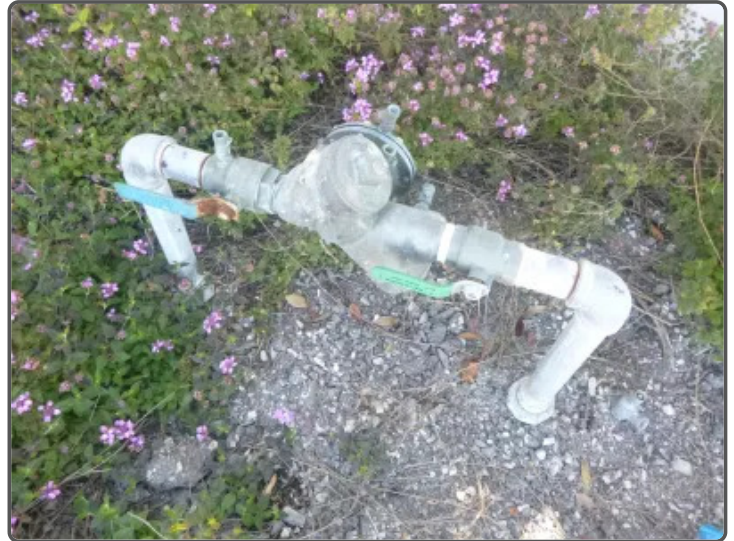
Comp # 1706 Backflow Devices - Replace

We recommend funding to replace these backflow devices approximately every 15 to 20 years. Remaining useful life based on current age and condition.

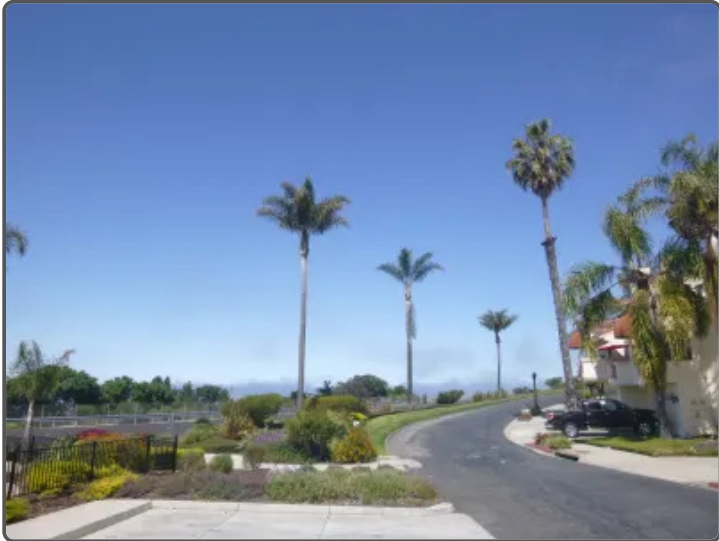
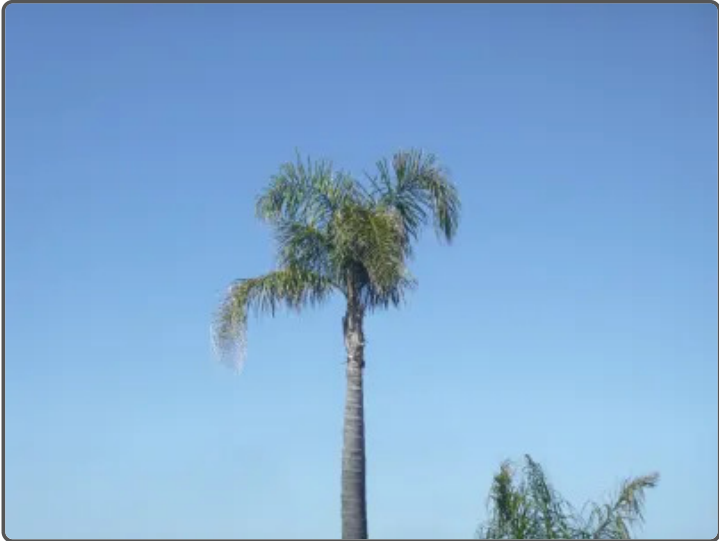
It was reported that these trees are trimmed when necessary as an operating expense.

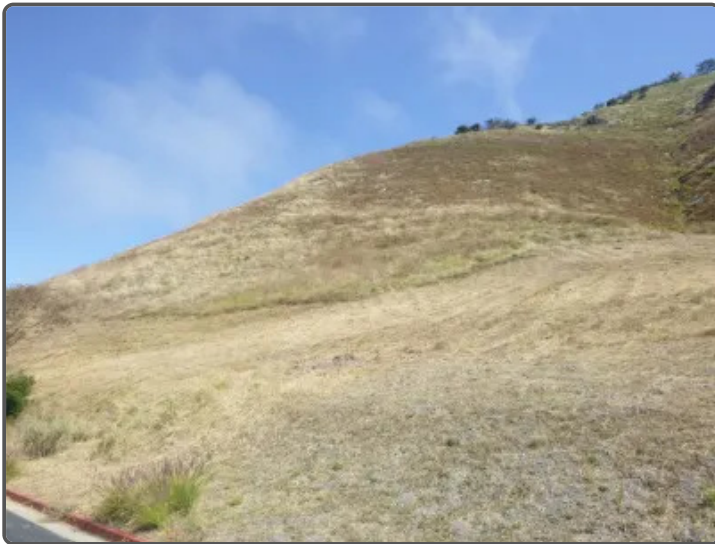
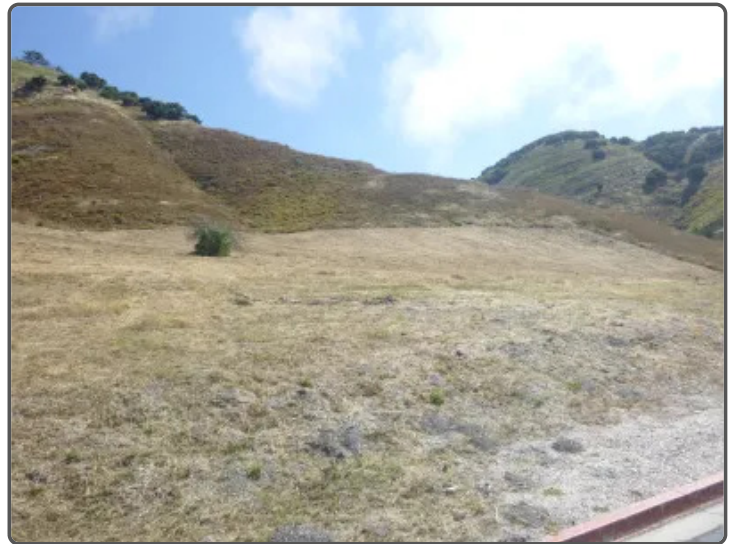
Comp # 1803 Hillside Erosion Control - Perform

The client reported that the association recently made improvements to repair or mitigate erosion. Although the necessity to perform this component is difficult to predict we have funded for a similar project approximately every 8 years. The useful life, remaining life and project cost were provided by the client.

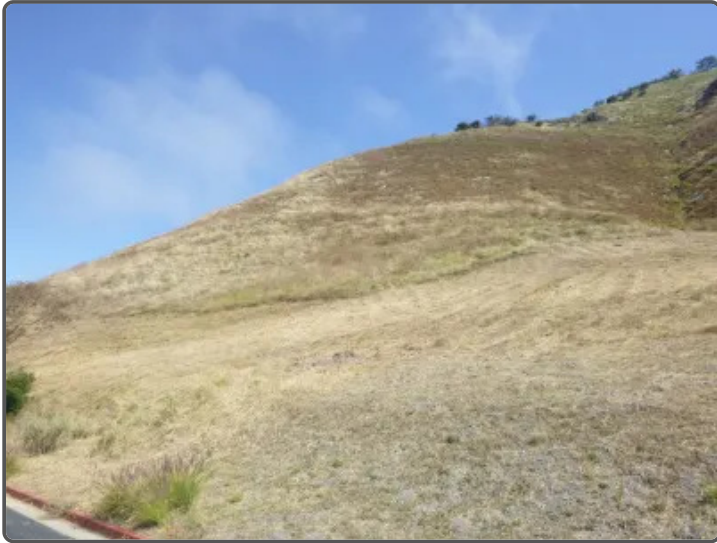
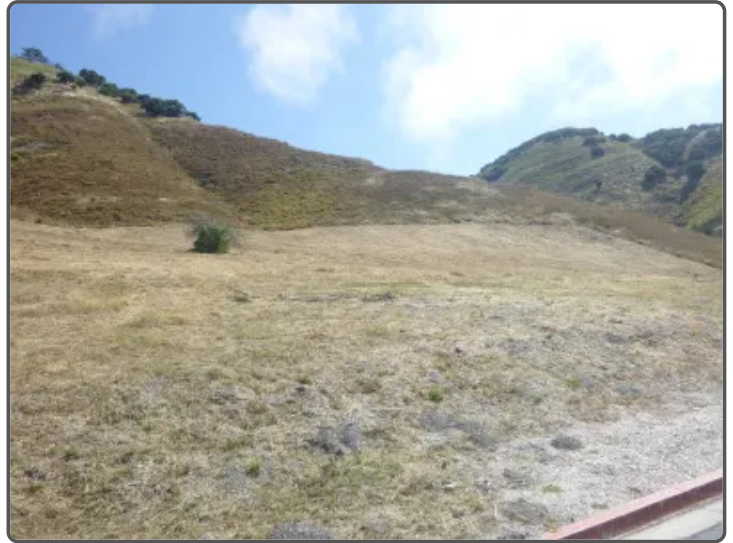
Comp # 1804 Hillside Fire Control - Perform

At the client's request we have funded for an allowance to perform hillside fire prevention maintenance approximately every 3 years. The project cost was provided by the client.

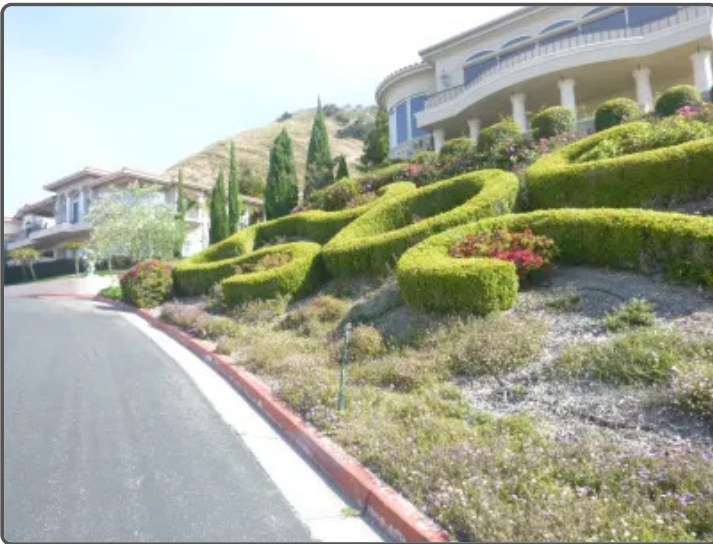
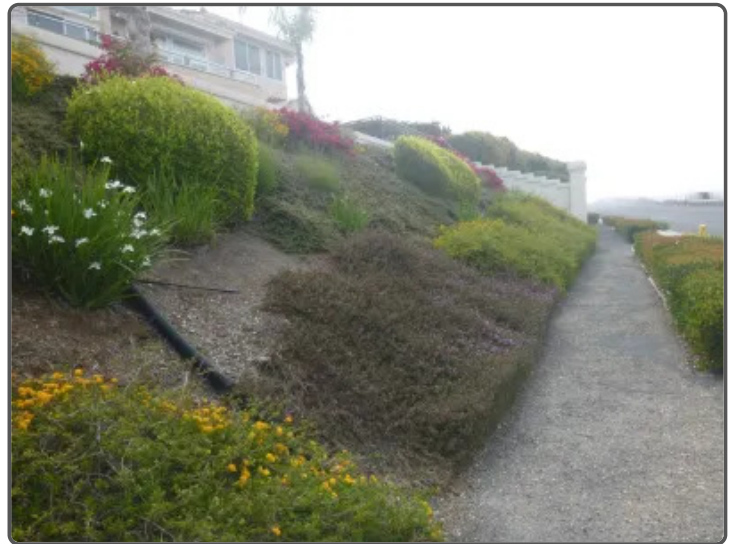
Comp # 1812 Landscaping / Irrigation - Renovate

No expectation to completely replace the landscaping. We recommend funding for an allowance to generally refurbish the landscaping, make local tree replacements, and make upgrades to the irrigation system approximately every 15 to 20 years.
